Infrared Inspection Report

Description: Thermal Properties Comparison

HomeCrete Homes Model
225 Bayshore Drive
Port St. Lucie, Fl.

Job #:
111607.001

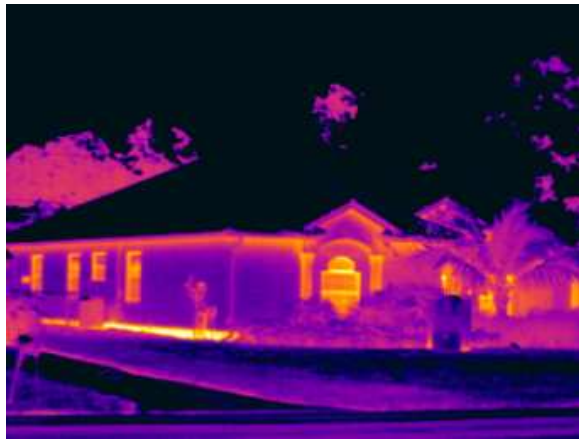
Description: IR Image #1
Thermal image of ICF construction

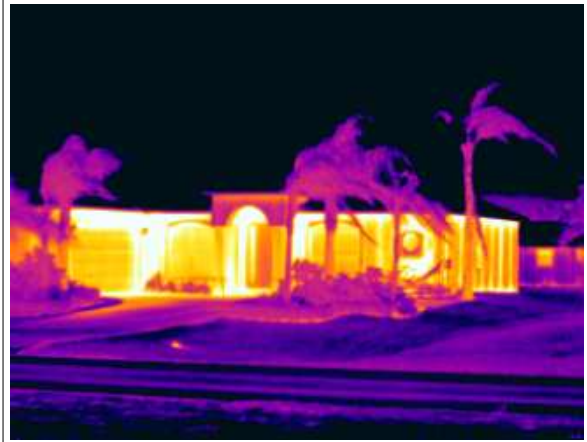
Description: IR Image #2
Thermal image of neighboring home with CBS construction showing considerably more heat loss

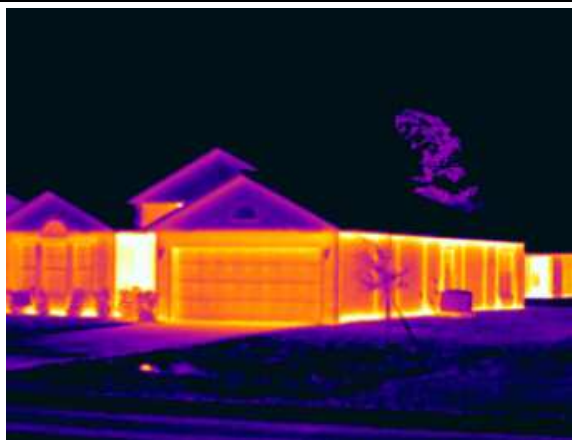
Description: IR Image #3
Thermal image of neighboring home with CBS construction showing considerably more heat loss

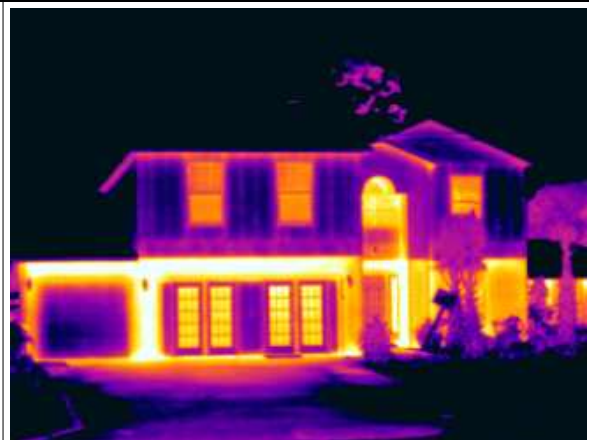
Description: IR Image #4
Thermal image of neighboring home with CBS construction showing considerably more heat loss

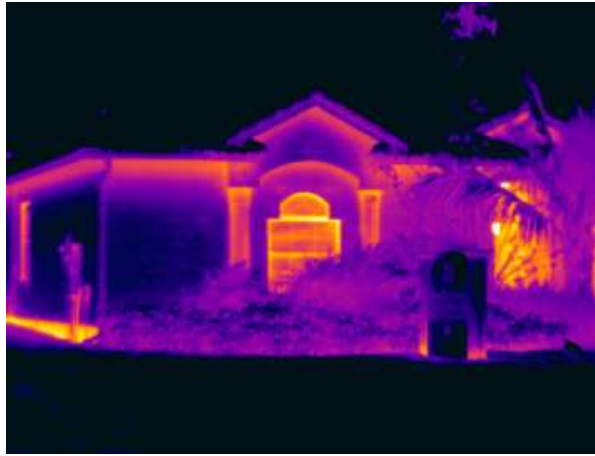
Description: IR Image #5
Thermal image of ICF construction

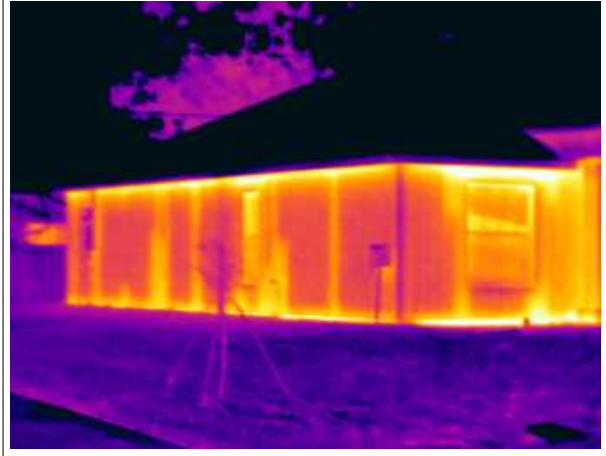
Description: IR Image #6
Thermal image of neighboring home with CBS construction showing considerably more heat loss

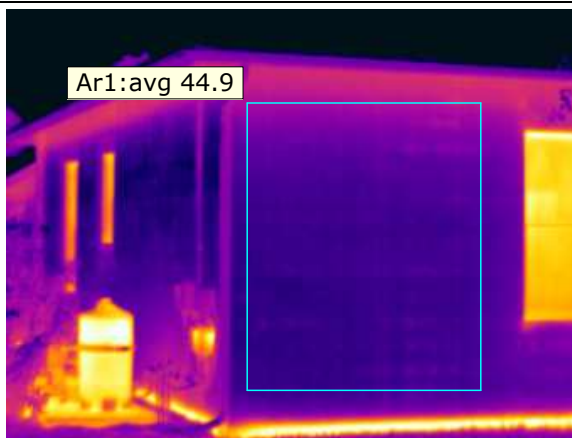
Description: IR Image #7
Thermal image of ICF construction

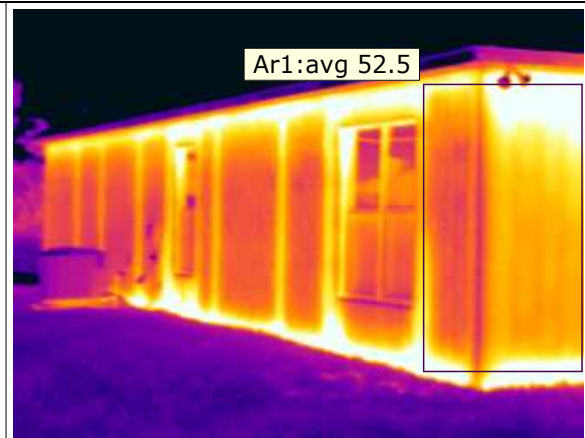
Description: IR Image #8
Thermal image of neighboring home with CBS construction showing considerably more heat loss

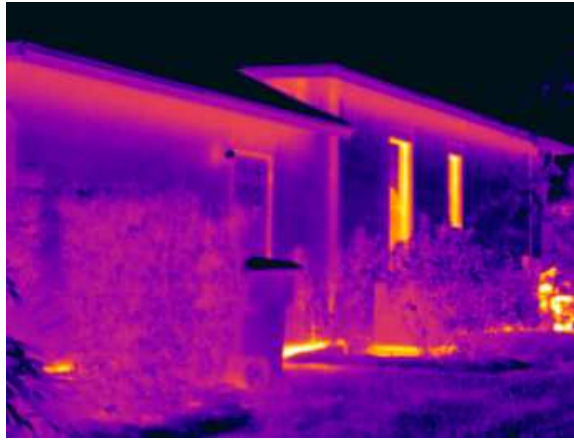
Description: IR Image #9
Thermal image of ICF construction

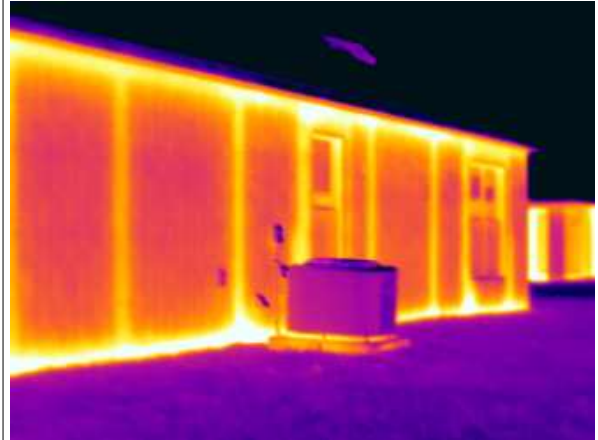
Description: IR Image #10
Thermal image of neighboring home with CBS construction showing considerably more heat loss

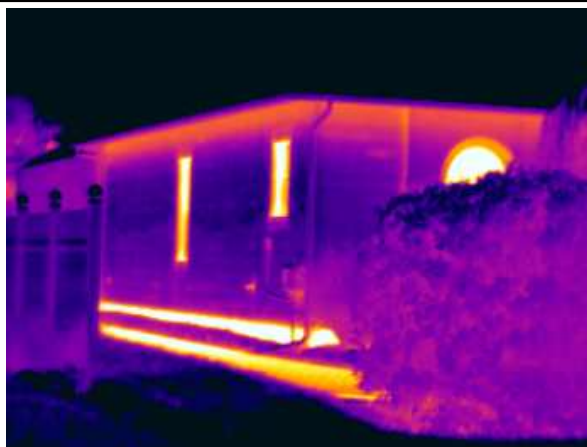
Description: IR Image #11
Thermal image of ICF construction

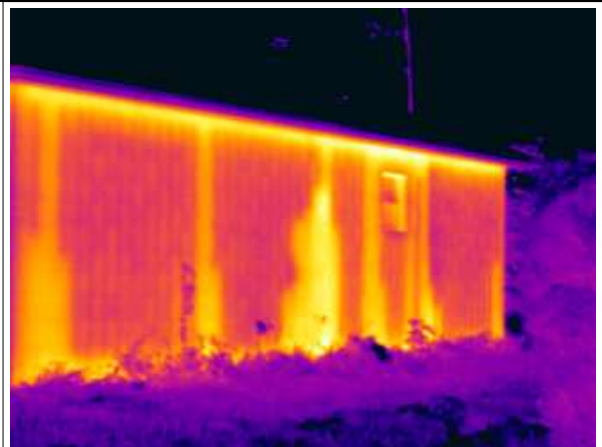
Description: IR Image #12
Thermal image of neighboring home with CBS construction showing considerably more heat loss

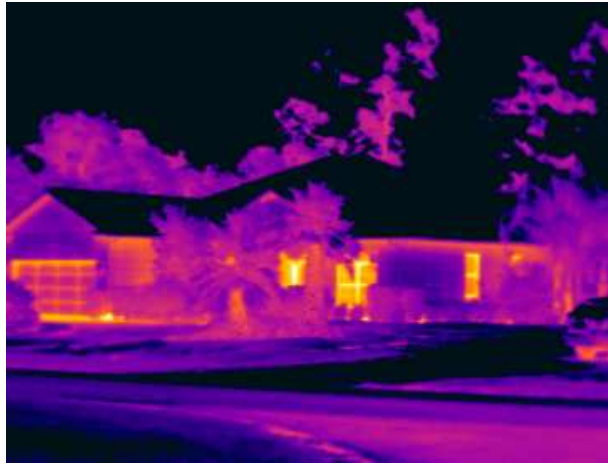
Description: IR Image #13
Thermal image of ICF construction

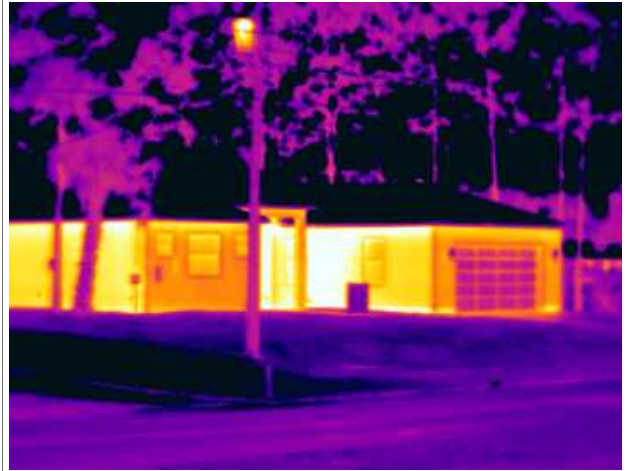
Description: IR Image #14
Thermal image of neighboring home with CBS construction showing considerably more heat loss

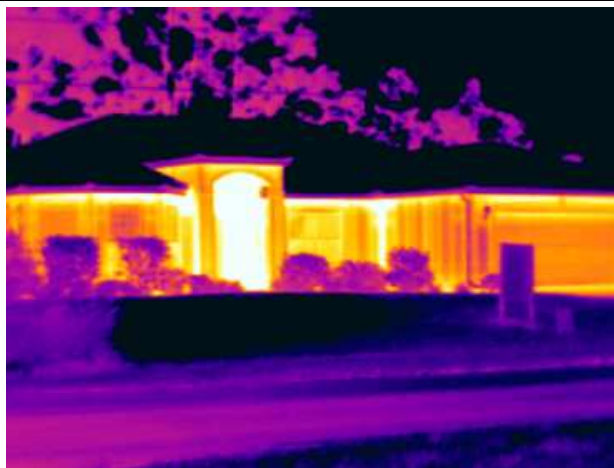
Description: IR Image #15
Thermal image of neighboring home with CBS construction showing considerably more heat loss

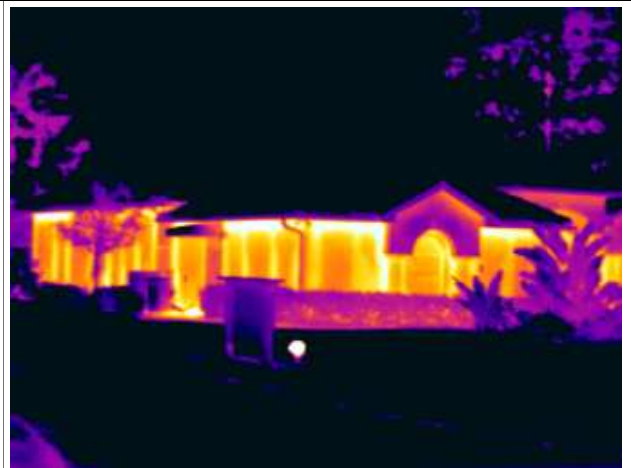
Description: IR Image #16
Thermal image of neighboring home with CBS construction showing considerably more heat loss

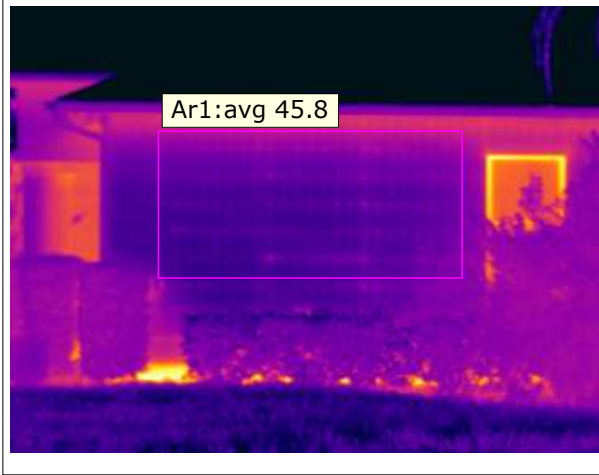
Description: IR Image #17
Thermal image of ICF construction

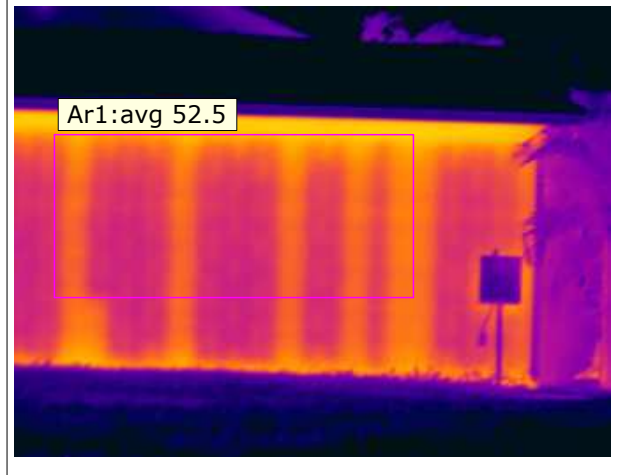
Description: IR Image #18
Thermal image of neighboring home with CBS construction showing considerably more heat loss

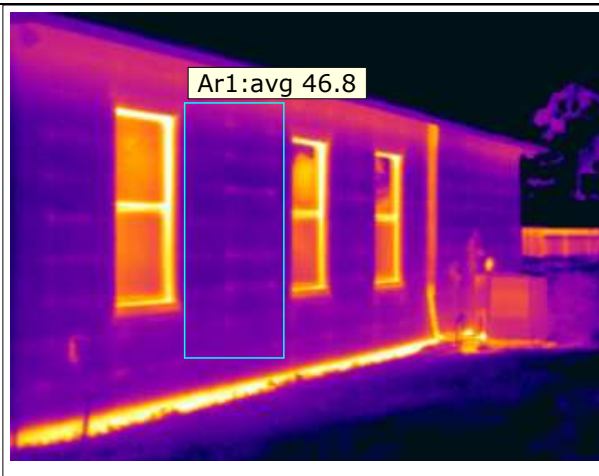
Description: IR Image #19
Thermal image of ICF construction

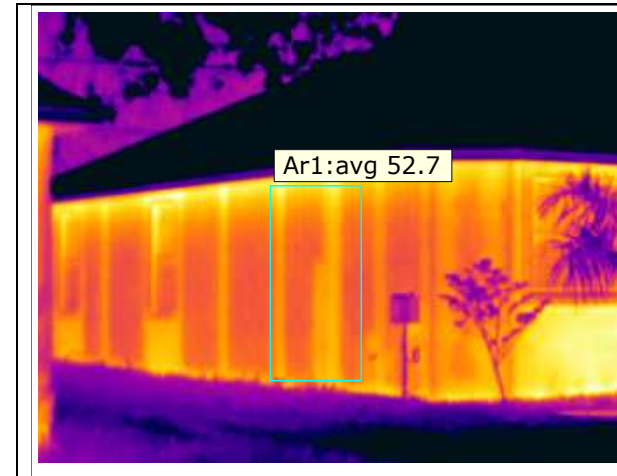
Description: IR Image #20
Thermal image of neighboring home with CBS construction showing considerably more heat loss
